Technical Report GL-94-1
January 1994

In Situ Geophysical Investigation of the Pile Test Section, Sardis Dam, Mississippi

Final report

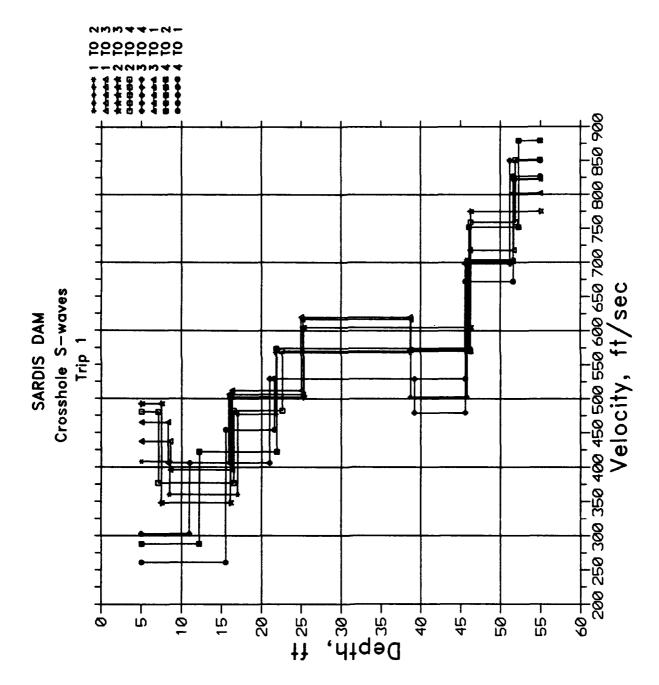
Figure 14. Crosshole S-wave velocity versus depth, Trip 1

The CROSSHOLE program results for the crosshole tests conducted during trips 1, 2 and 3 are presented as plots of velocity versus depth as shown in Figures 14 through 16, respectively. The velocities obtained for each boring set during trip 1 (Figure 14) agree very well with the exception of the upper 15 ft. The velocity discrepancy between boring sets in the upper 15 ft is probably due to the inability to accurately pick the time of arrival of the S-wave because of signal attenuation through the loose soil (fill) in this depth interval. Velocity agreement between boring sets for trips 2 and 3 (Figures 15 and 16) are also very good. It is noted that the velocities measured between borings 4 and 1, indicated in Figures 15 and 16 by the filled circles, are significantly higher than the velocities for the other borehole sets. The pile, located between borings 1 and 4 (Figure 17), has a marked effect on the surrounding soil as illustrated by the high S-wave velocity between these two borings. The increased S-wave velocity between these borings was presumably chiefly caused by the densified soil surrounding the pile rather than the pile itself. Based on an S-wave velocity for concrete of 8000 fps (Rix 1988) the time for an S-wave to travel trough a 24-in concrete pile would be approximately 0.25 msec, a very small fraction of the average travel time of 13.5 msec.

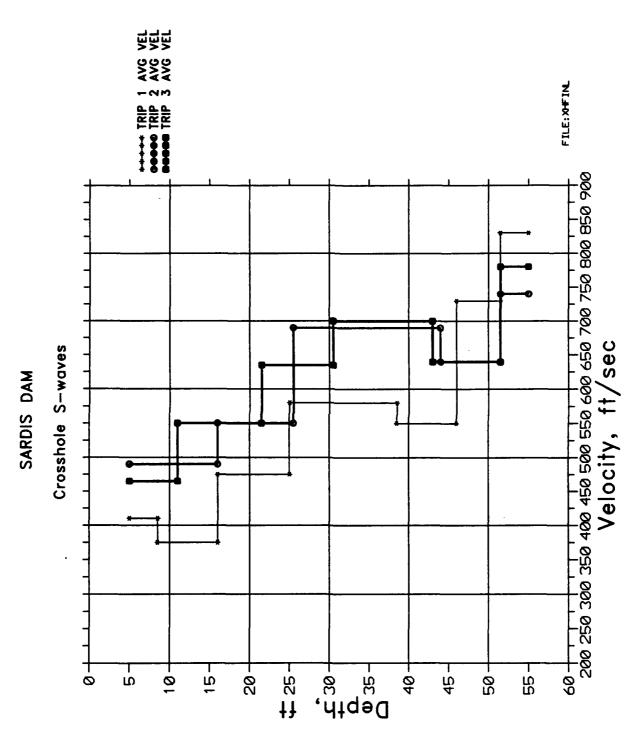
Figure 18. Average crosshole S-wave velocities for Trips 1, 2, and 3

Average velocity profiles were determined for the three trips and are shown in Figure 18. The Figure 18 shows that the post-treatment velocities are considerably higher than the pre-treatment velocities. It is noted that the velocities obtained from crosshole tests conducted between borings 4 and 1 were not used to determine the average velocity profiles for trips 2 and 3 (post-treatment).

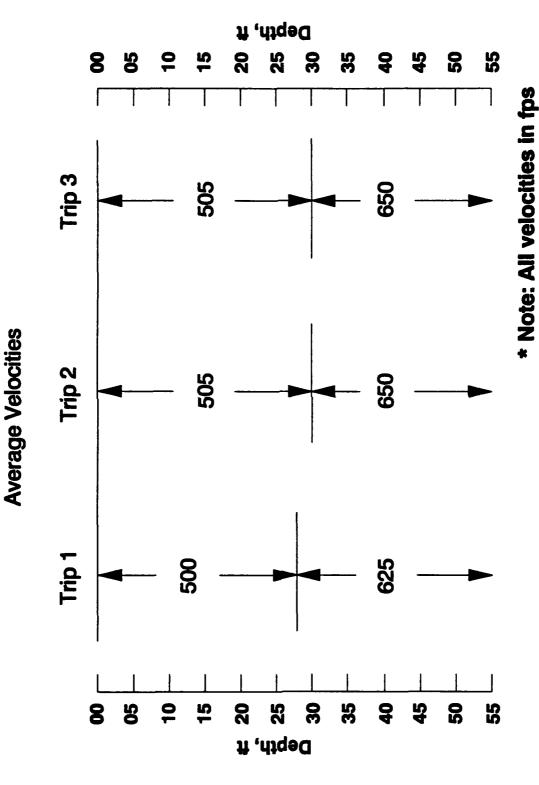
Figure 34. Average downhole S-wave velocities for Trips 1, 2, and 3

show that for a given trip the downhole S-wave velocities agree very well between borings. Figure 34 presents the average downhole velocities for the each of the three trips. The results indicate basically two velocity layers with the layer interface occurring at an approximate depth of 30 ft. Referring to Figure 34 it can be seen that the average velocities for trip 1 are lower than those for trips 2 and 3 however, they are not considered significantly lower. Thus, it can be concluded that no significant S-wave velocities differences were noted between pre- and post-treatments using the downhole testing method.
